CENTER FOR ENERGY AND ENVIRONMENT RESEARCH  
UNIVERSITY OF PUERTO RICO

# Oceanic Corrosion Test of Bare and Zinc-Protected Aluminum Alloys for Seawater Heat Exchangers

November, 1982

Prepared for National Aeronautics  
and  
Space Administration  
under  
Grant No. NAGW-198

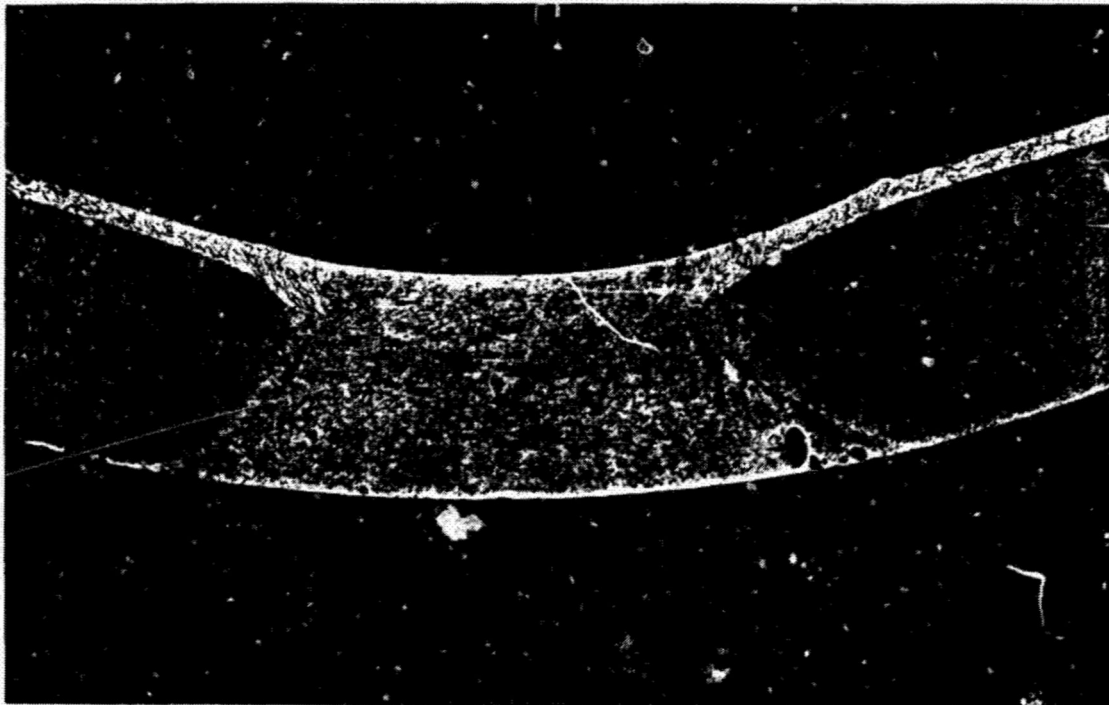
FIGURE 9. Weld seam on the RFW tubes. The seam was approximately 3.2 mm wide and was not covered by Alclad. Etch - Kellers, magnification 20X.

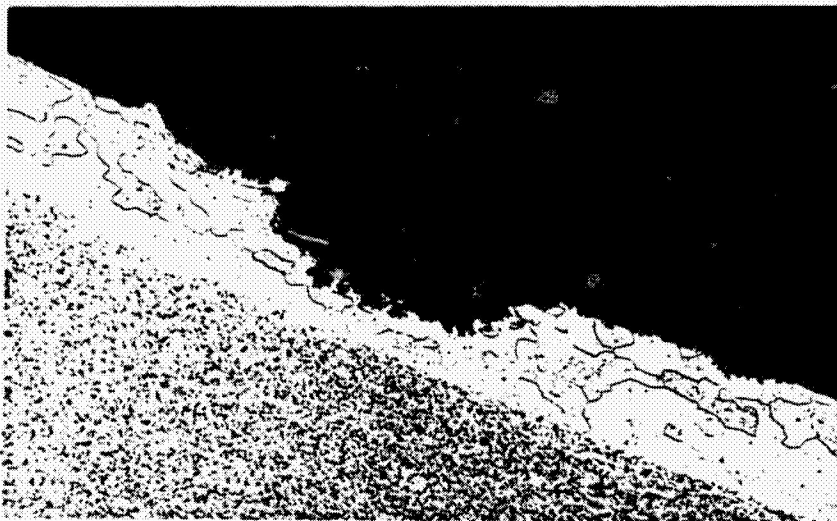
a. 10% Alclad 3004  
(C-6) Transverse  
cross section 65  
d. chlorinated

Pitting was observed in two instances, both Alclad tubes. Tube C-6 (10% Alclad), exposed for 65 days to chlorinated seawater, had three pits near one end. A cross section of the deepest pit is shown in Figure 19a. The pit is 0.119 mm (4.7 mils) deep and confined to the 7072 clad layer. Figure 19b shows a cluster of pits observed near one end of tube B-30, exposed for 90 days to chlorinated seawater. The deepest pit is shown in cross section in Figure 19c. Depth was 0.061 mm (2.4 mils), and again the pitting was confined to the clad layer.

Deepest pit of  
three pits  
observed

Pit depth - 4.7  
mils. Pitting is  
confined to 7072  
clad layer.

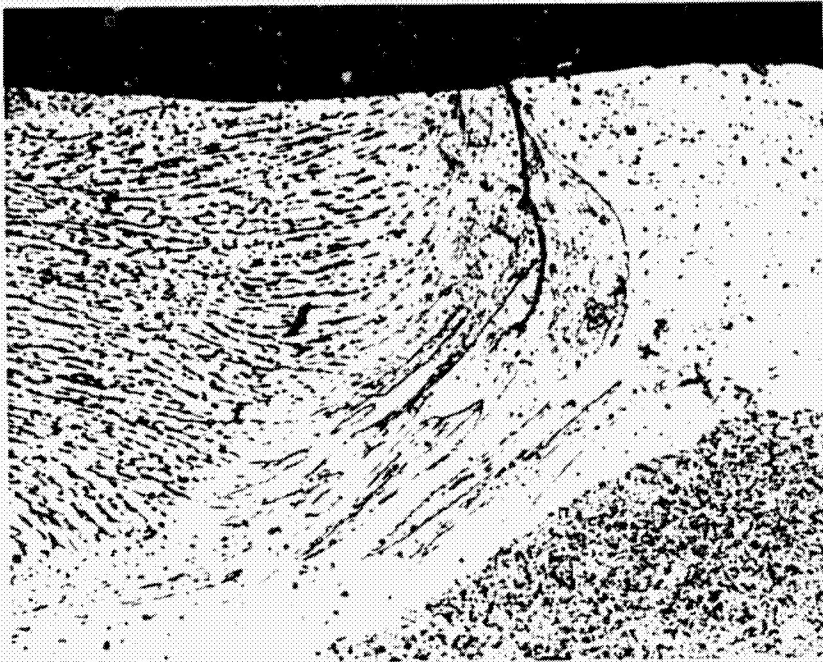
a. 10% Alclad 3004 (C-30) Weld crack in 1-inch heliarc welded RFW tubing.

185 d.,  
chlorinated

Note absence of selective attack of weld, HAZ or crack crevice.

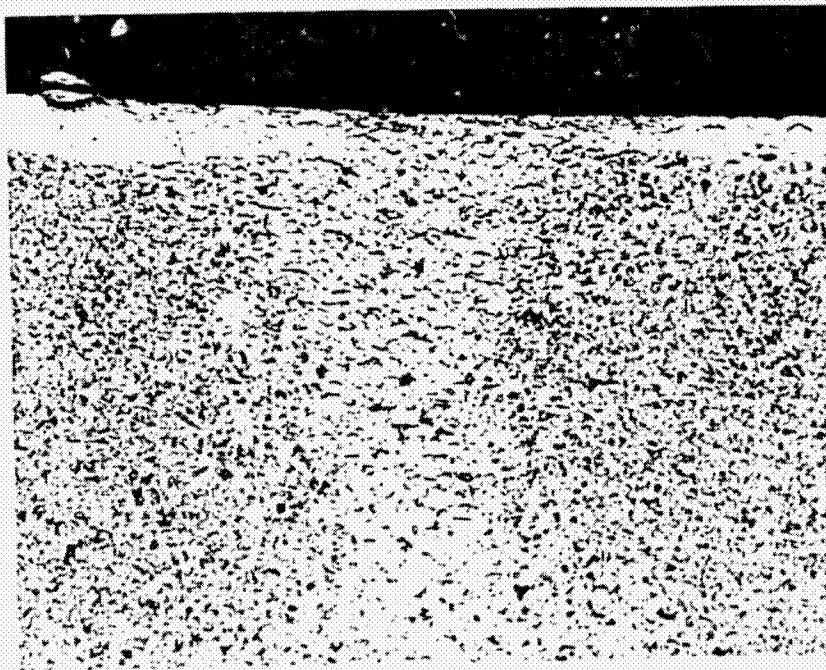
b. High-frequency AC induction weld in 3-inch Alclad RFW tubing.

Note narrow weld zone and absence of cracks.

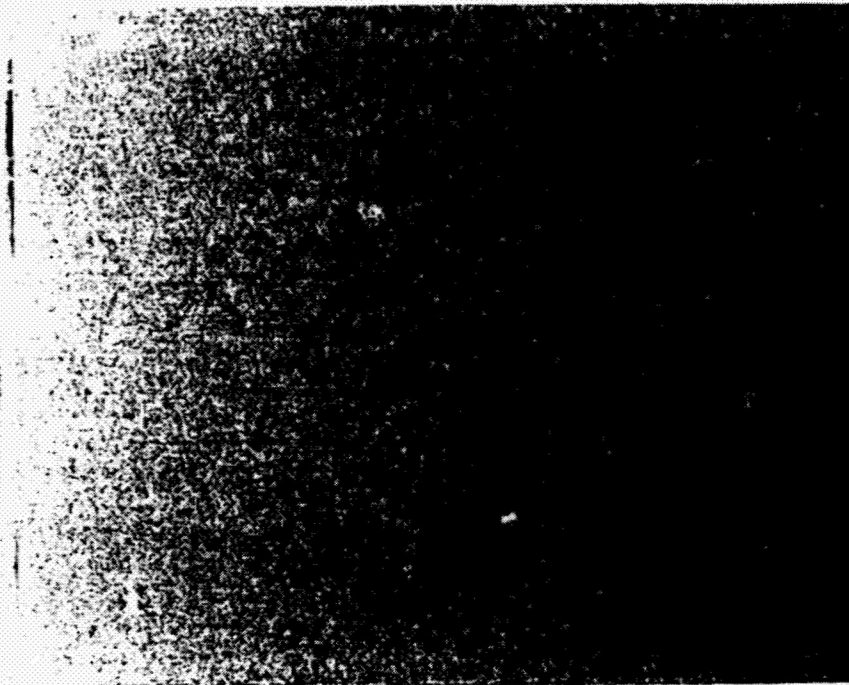
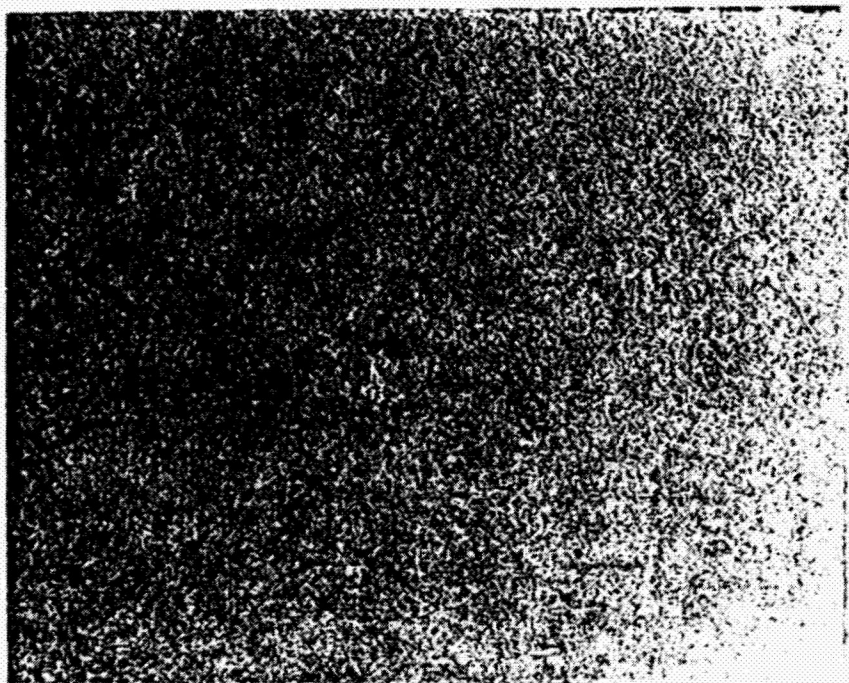
FIGURE 2.. Typical appearance of corrosion on FB-BARE 3003 after 185 days. Magnification 3X above and 10X bottom.

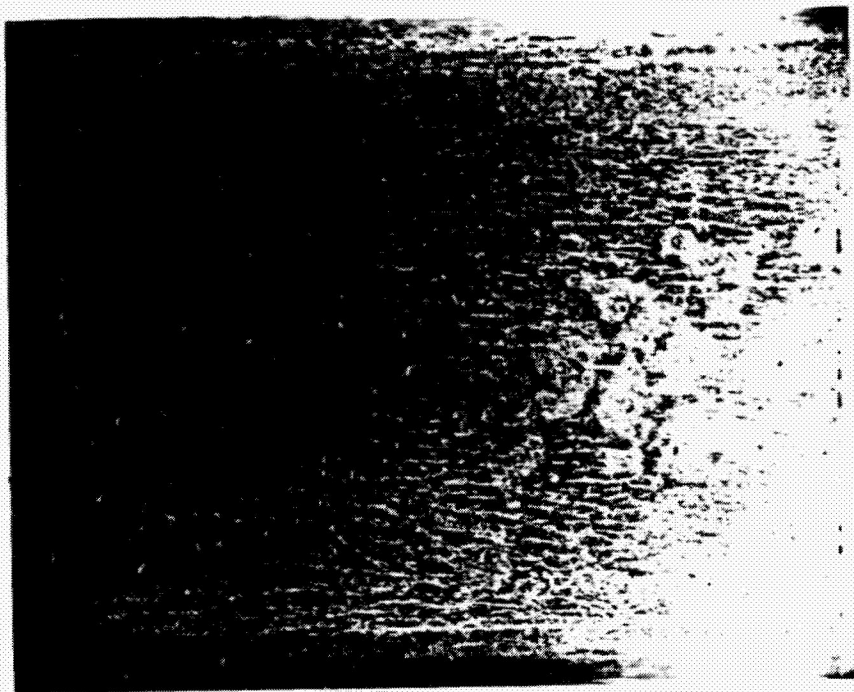
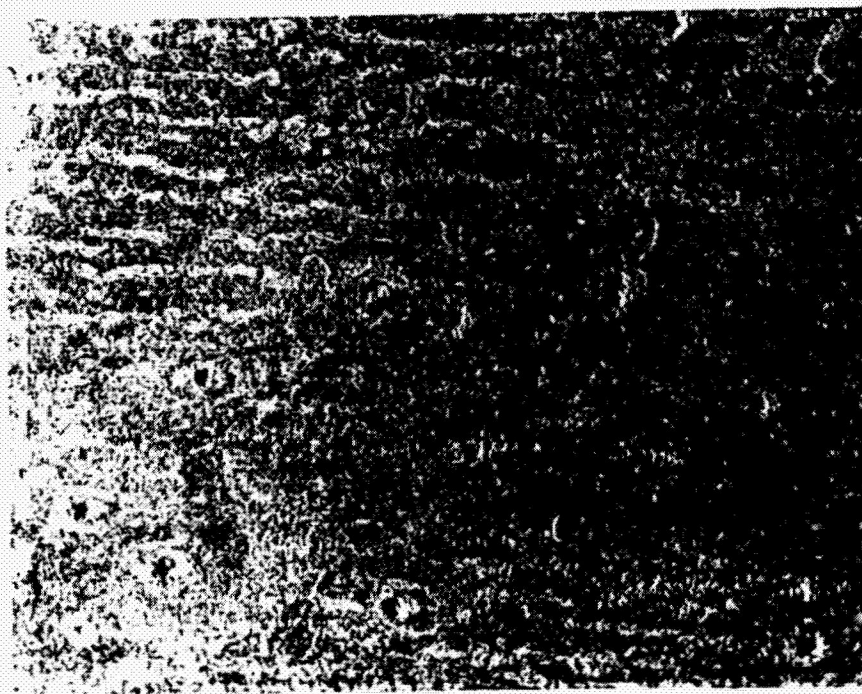
FIGURE 28. Typical appearance of corrosion on FB-ZN after 185 days. Magnification 3X above and 10X bottom.

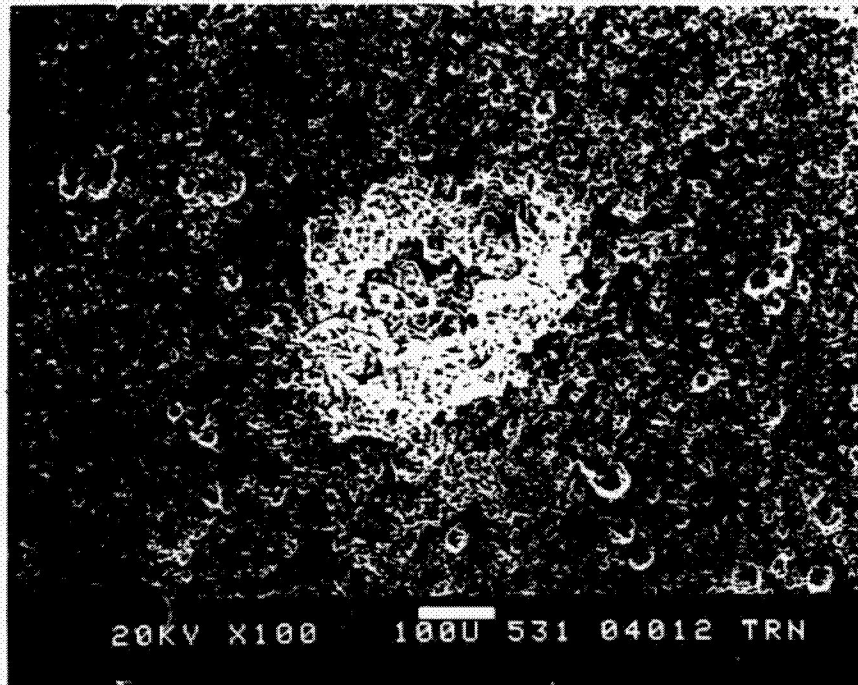
FIGURE 29. Typical corrosion pit on FB-ZN after 185 days. Magnification 100X.

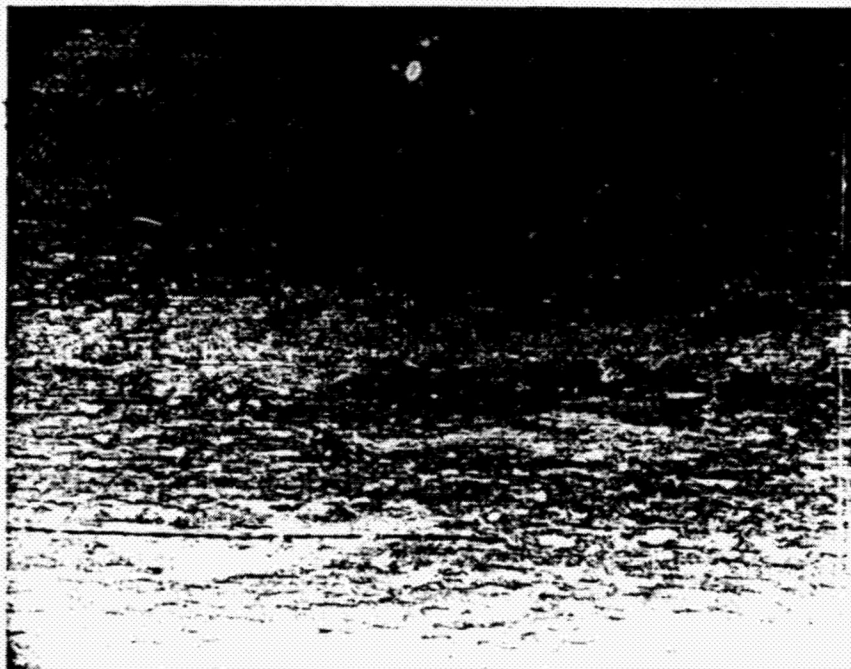
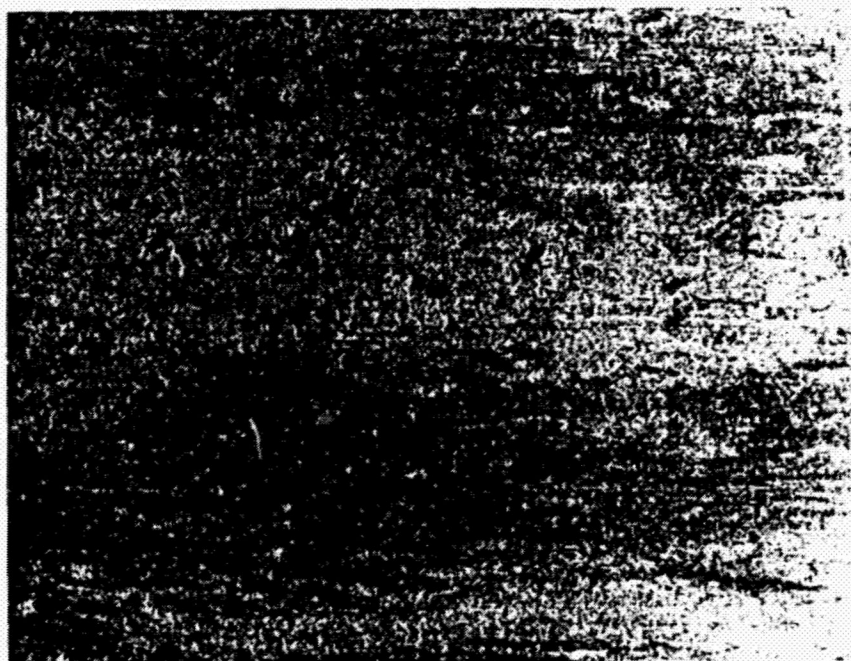
FIGURE 31. Typical appearance of corrosion on VB-ZN after 185 days. Magnification 3X above and 10X bottom.

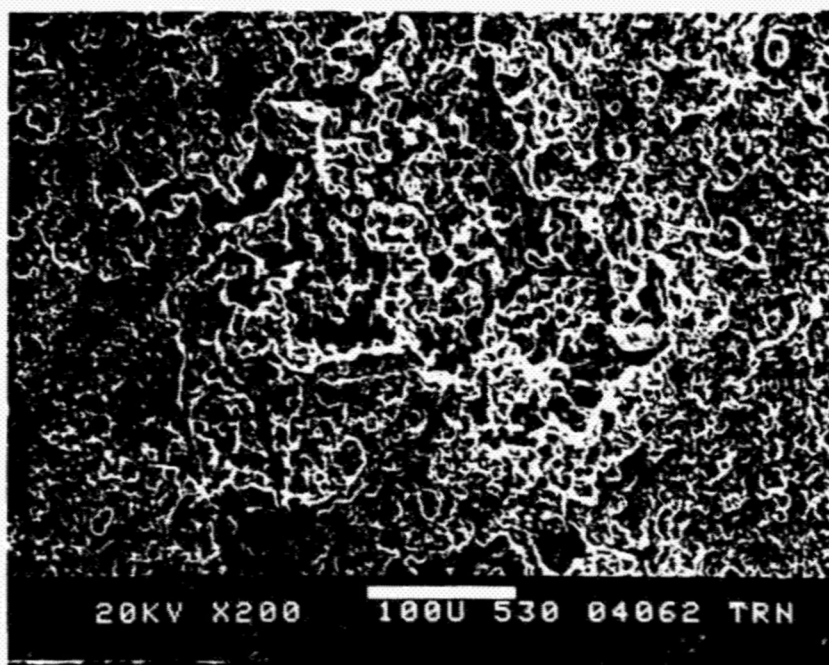
FIGURE 32. Typical corrosion pit in VB-ZN sample after 185 days. Magnification 200X.

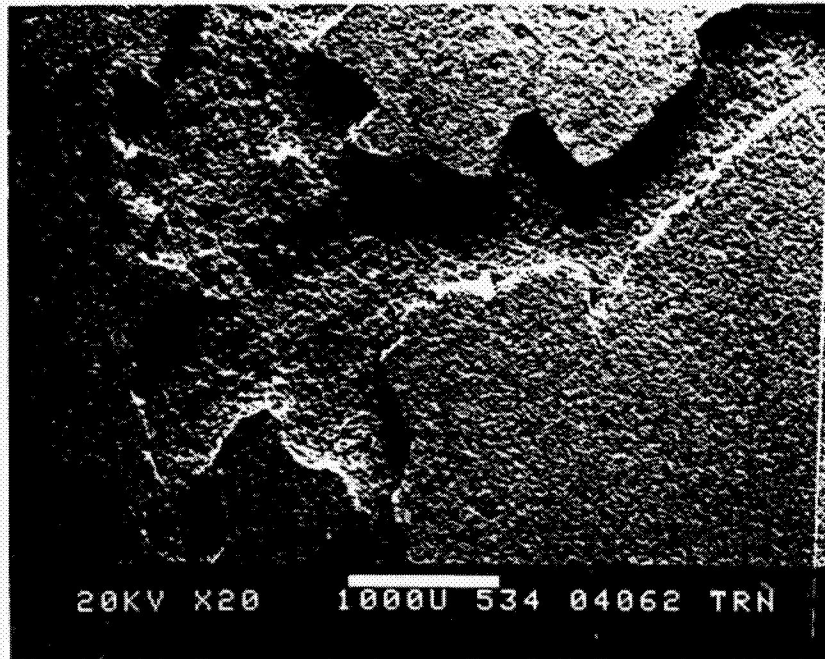
FIGURE 34. Corrosion channel in VB-ZN sample. Sample AV10 was corroded in flow direction. Corrosion occurred by galvanic action in diffused zinc areas adjacent to low zinc areas. Magnification 20X

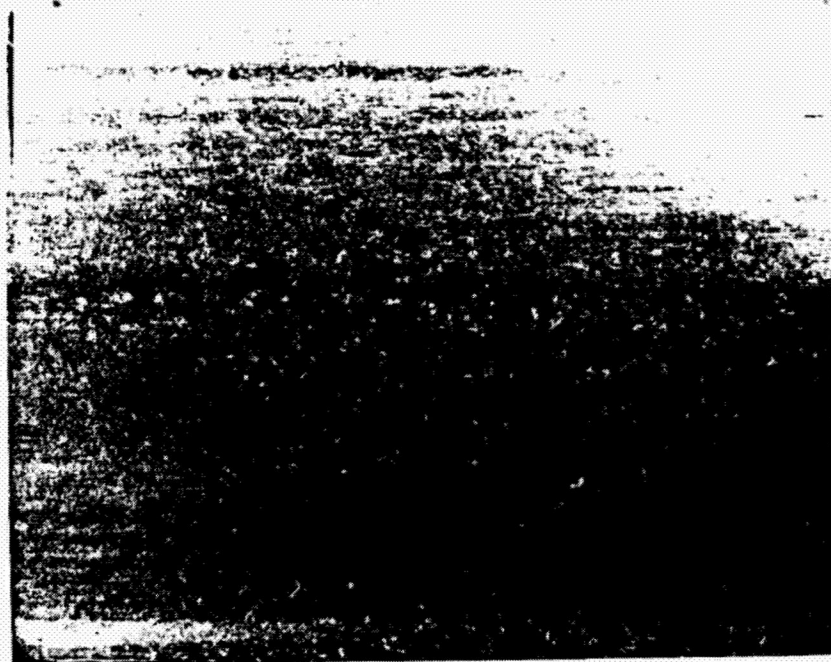
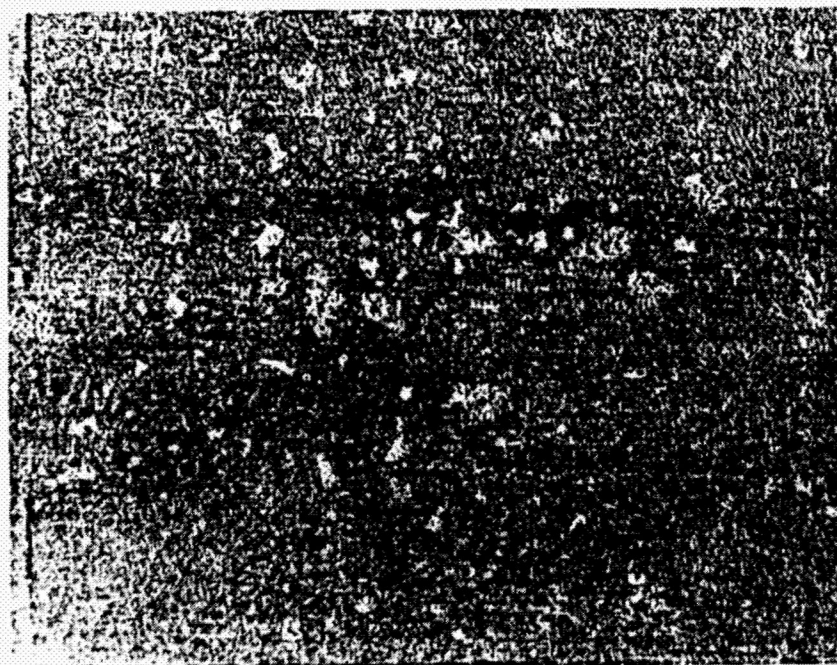
FIGURE 36. Typical appearance of corrosion on FB-ETCH-1 ZN after 185 days. Magnification 3X above and 10X bottom.

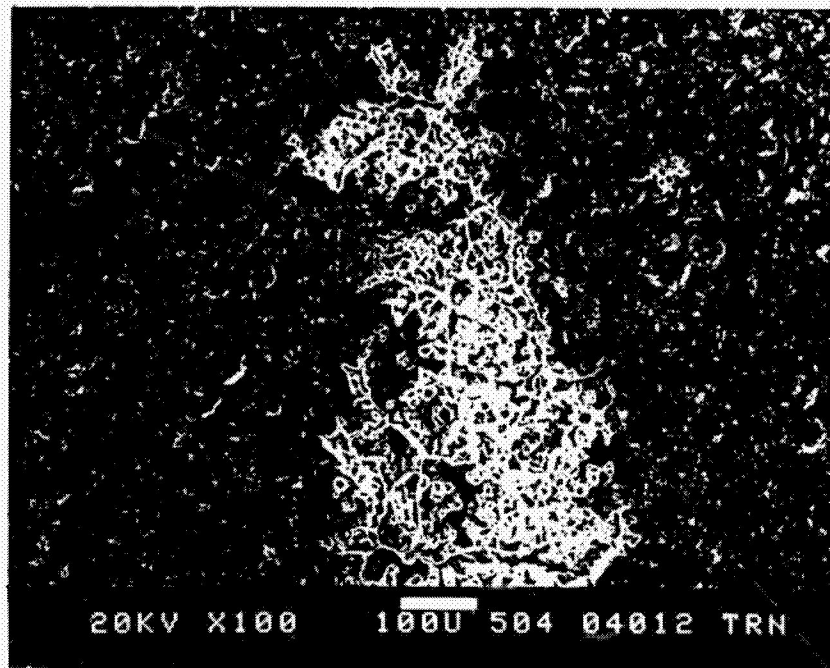
FIGURE 37. Typical corrosion pit in FB-ETCH-1 ZN sample after 185 days.

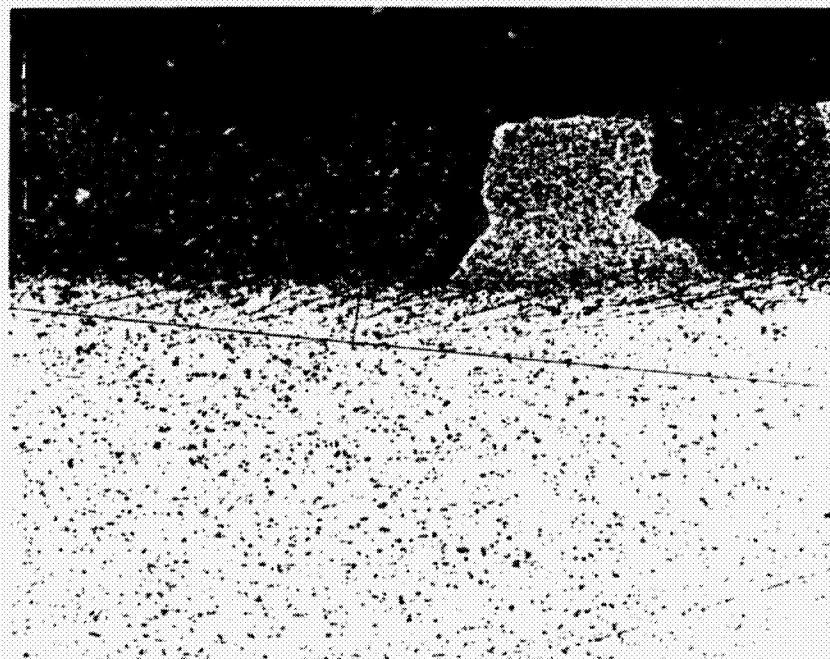
FIGURE 38. Corrosion pit in FB-ETCH-1 ZN samples. They were generally shallow. Pit shown is 0.001 in. deep. Etch - Poultons etch. Magnification 100X.

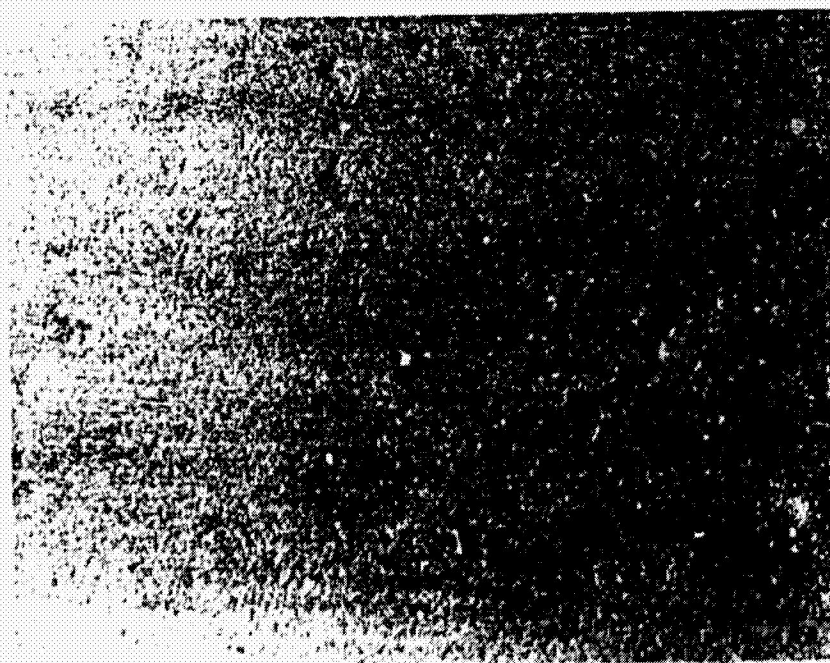
FIGURE 39. Typical appearance of corrosion on FB-ETCH-1/2 2N after 185 days. Magnification 3X above and 10X bottom.

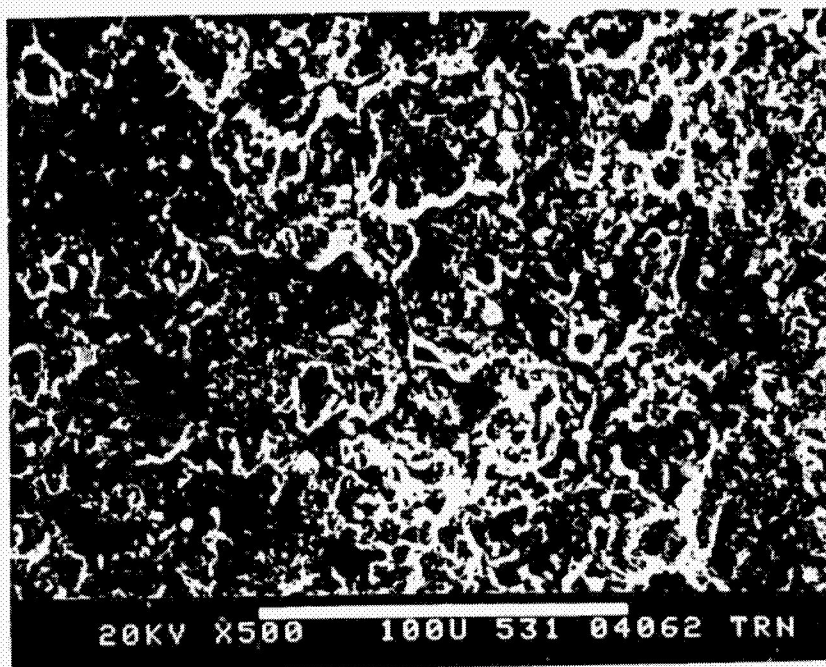
FIGURE 40. Pitting attack on the FB-ETCH-1/2 ZN sample. On these samples as well as on other samples with diffused zinc, pitting attack started at grain boundaries and broadened. Magnification 100X.

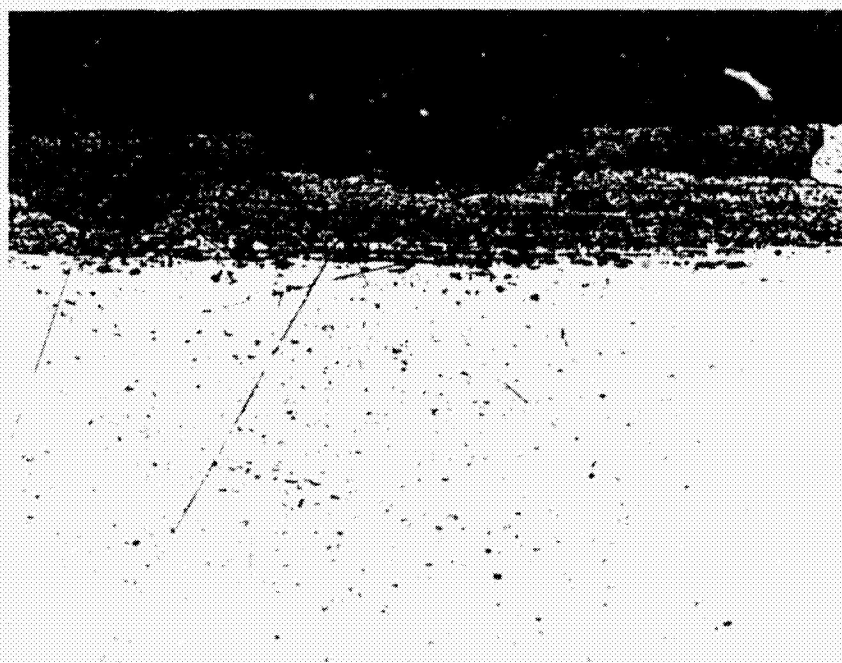
FIGURE 41. Corrosion pits in FB-ETCH-1/2 ZN samples. Pits were generally shallow and broad. Pit shown is 0.003 in. deep. Etch - Poultons Etch. Magnification 100X.

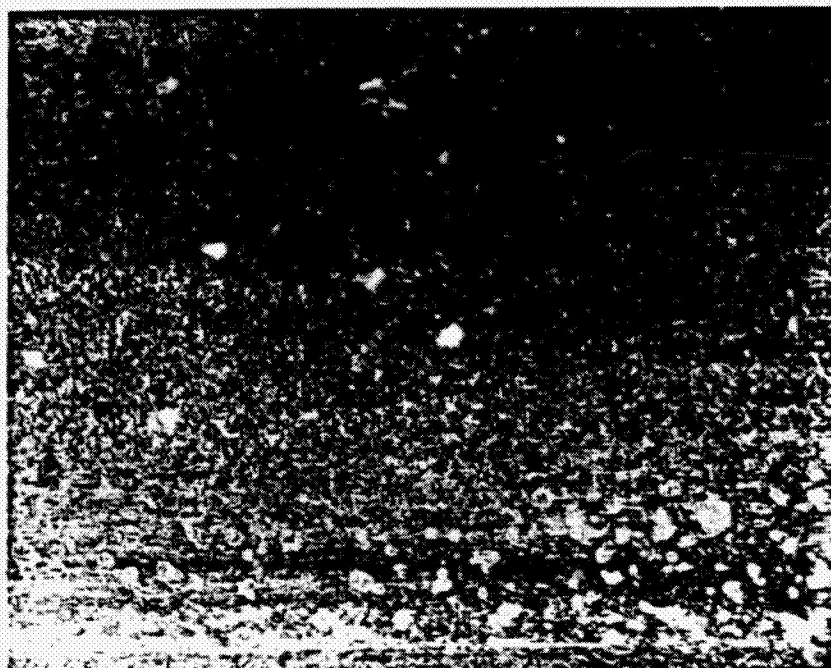
FIGURE 42. Corrosion of N-Fe samples. These samples were corroded by intergranular attack over much of the area exposed to seawater. Magnification 3X.

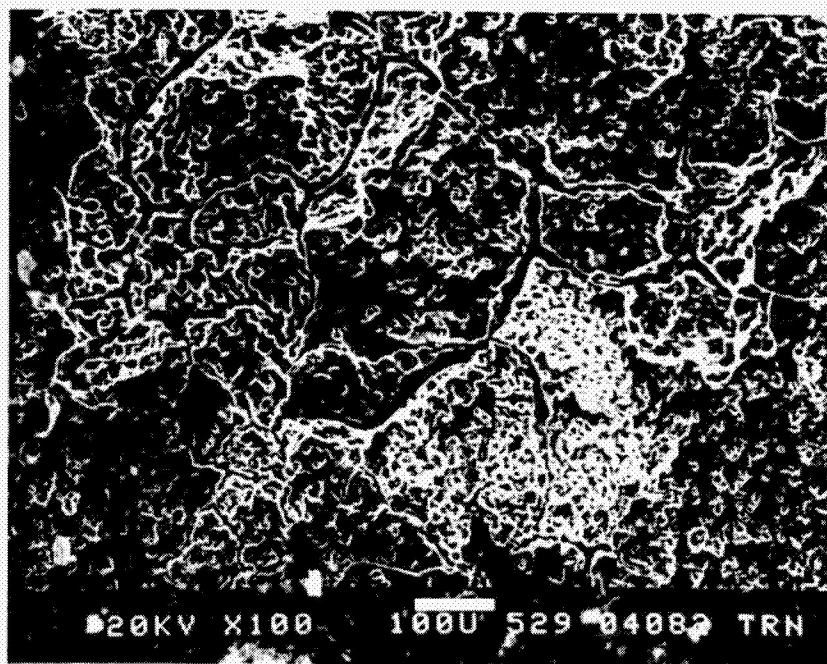
FIGURE 43. Corrosion of FE-ZN-TP sample. Corrosion was highly localized in grain boundaries. Magnification 100X.

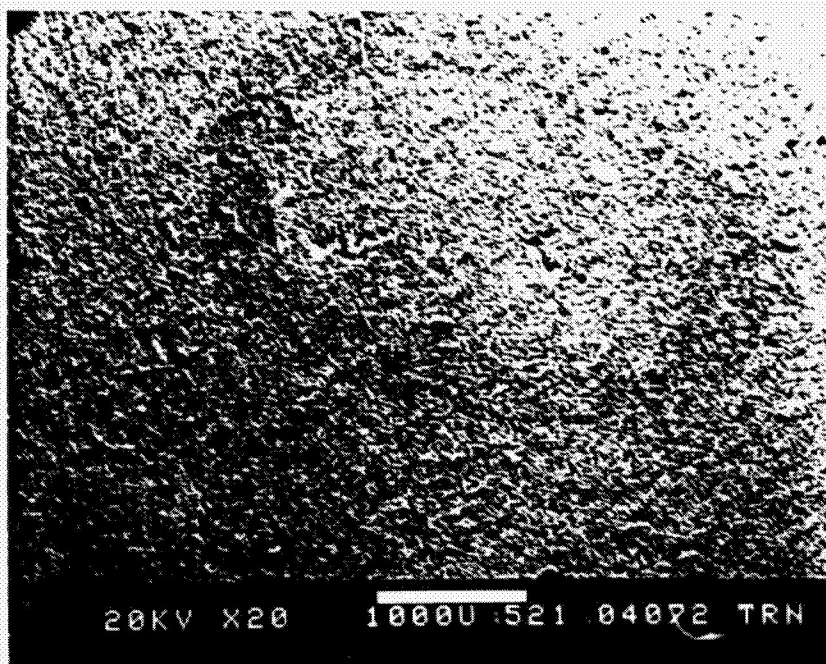
FIGURE 45. Corrosion pits in surface of 5% Alclad 3004 sample B30 after 90 days exposure. Magnification 20X.

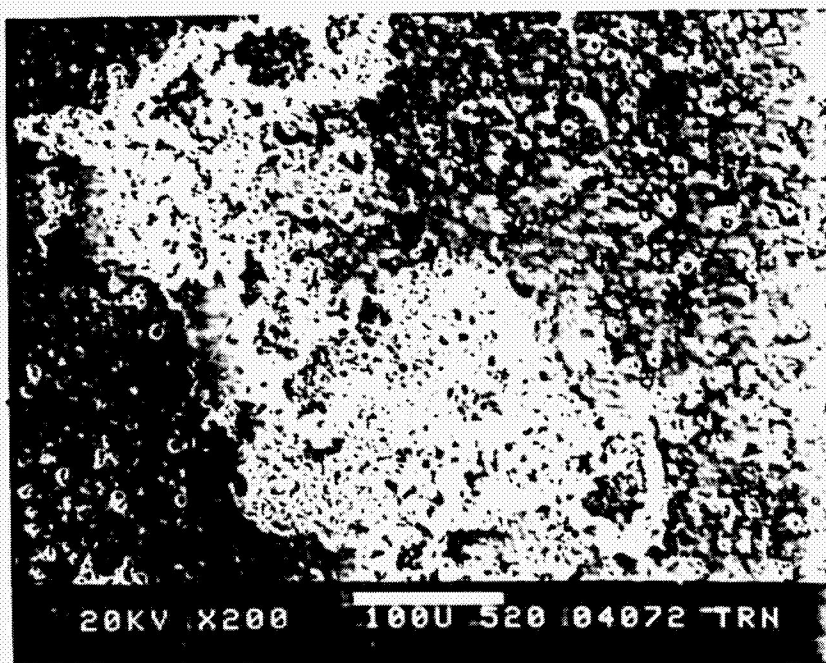
FIGURE 46. Typical appearance of corrosion pits in sample B30. Magnification 200X.

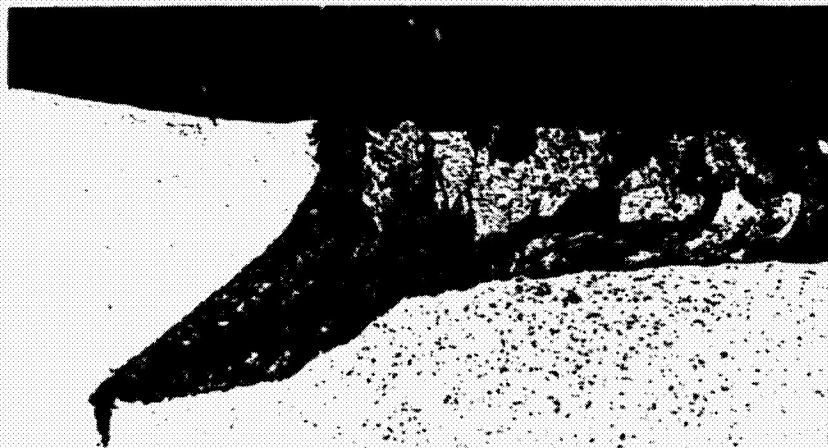
The SEM studies showed that no localized corrosion occurred at the weld seams or at cracks in the welds on the roll formed and welded tubes as shown in Figures 48-49.

FIGURE 48. No localized corrosion occurred at the weld seam in the RFW Alclad tubes. Etch - Poultons Etch. Magnification 100X.

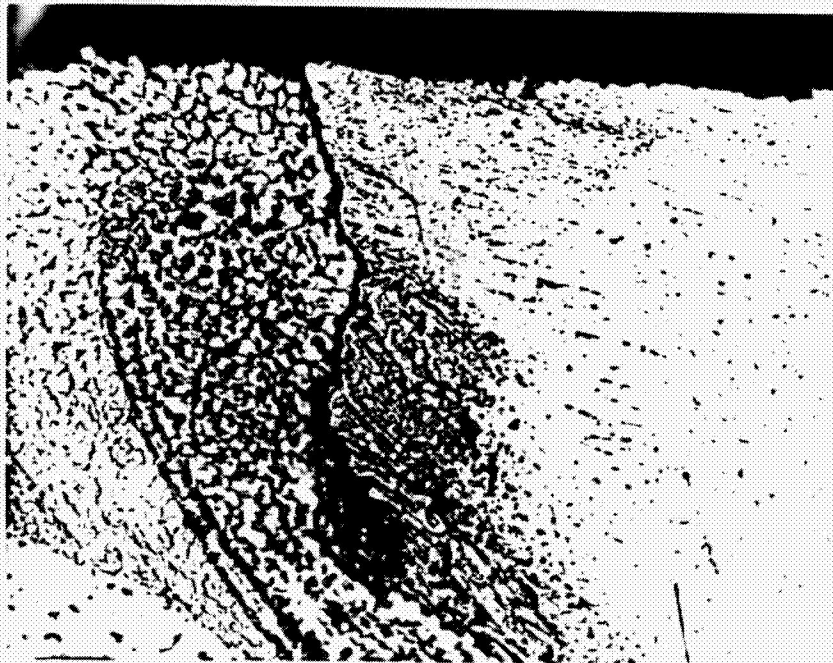
Fig. 40 No localized corrosion occurred in the weld cracks  
on the RFW Alclad tubes. Etch - Poulton; Etch.  
Magnification 500X.
